Attachment M
2009 Reclamation Plan Amendment

Reclamation Plan Amendment
for
Permanente Quarry
State Mine ID # 91-43-0004

Lehigh Southwest Cement Company

EnviroMINE Inc.

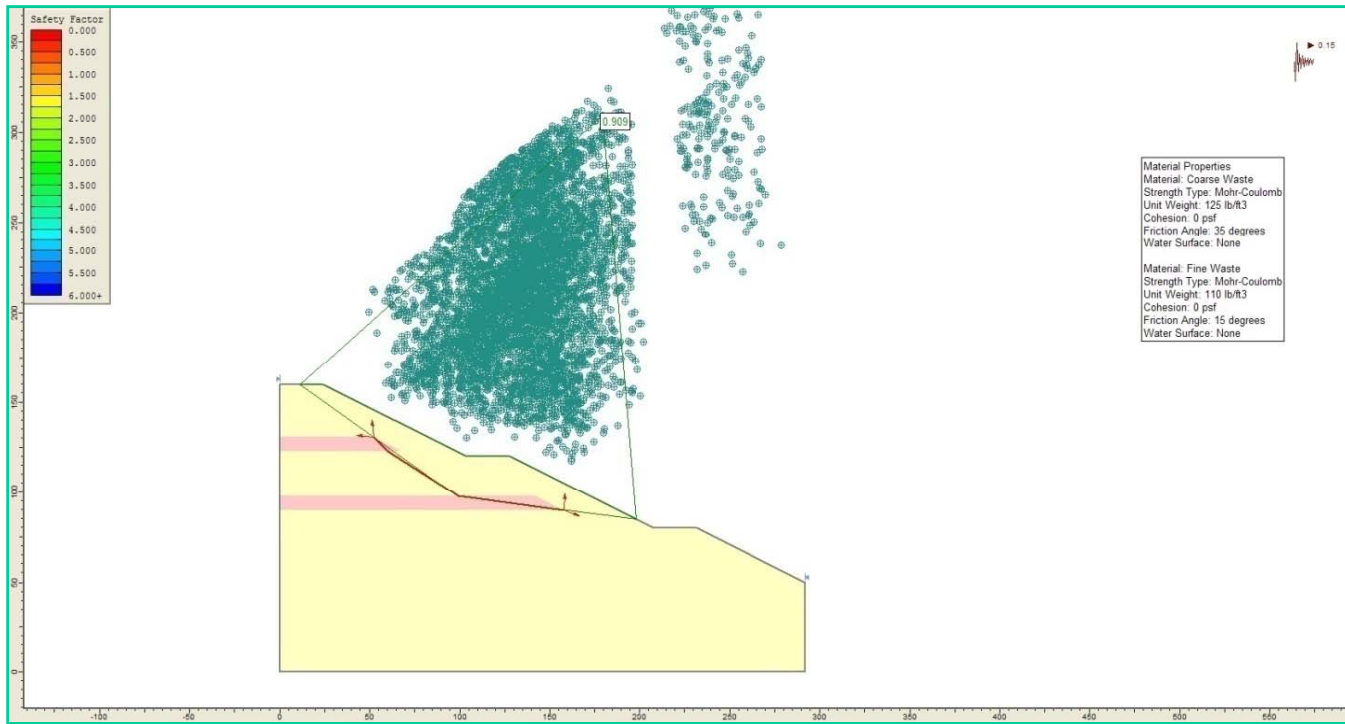
CONCEPTUAL SECTION – PSEUDO-STATIC
 LOCAL BLOCK FAILURE THROUGH FINE WASTE
 (FOS = 0.91)
